Repair Manual for E and D-series Small Capacity Pumps

This manual contains valuable repair information for the DW-1Z, DW-HZ, EG-1Z, and EC-HZ pumps and describes how to change a mechanical shaft seal assembly, gear set, and bypass valve cartridge.

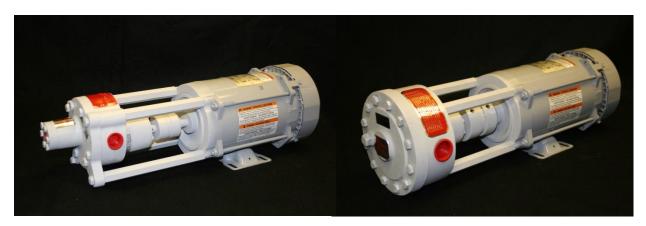
D-series Pump

E-series Pump

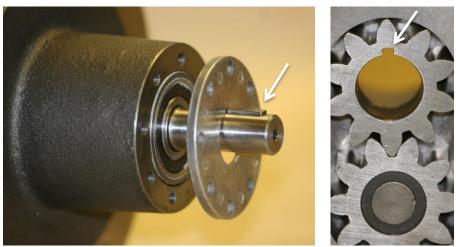
Replacement shaft seal assembly inserted into main housing with key in 12 o'clock position to fit drive gear keyway also in 12 o'clock position

Apply a **small** amount of grease to the inside of the pump housing where the shaft seal assembly will be installed. This will make the installation easier. Never use oil or WD-40 type lubricants. Now slide the replacement seal assembly into place. Make sure that the coupling key is in the 12 O'clock position. This recommendation is made so that the replacement mechanical seal will slide easily through the keyway in the drive gear which cannot be seen. When sliding in the replacement shaft seal assembly and resistance is felt, this means that the drive gear key does not quite line-up with the keyway in the drive gear. If this happens, rotate the shaft a little each way while gently pushing the shaft seal assembly in until the key is felt to enter the drive gear keyway. Then push the shaft seal assembly the rest of the way in. Do not use a hammer to drive the replacement seal in place. If the shaft seal assembly cannot be installed as above due to too much resistance, this may indicate a severely worn-out gear set. Refer to the second part of this manual entitled FOR A GEAR SET REPLACMENT and follow all steps to replace the gear set.

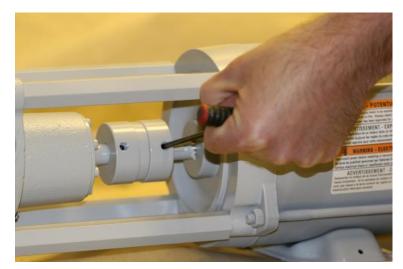
Tightening of coupling set screw using allen wrench

Tighten the coupling set screw and rotate the pump shaft to make sure it turns freely.
