REPAIR MANUAL FOR "GC-1" AND "MC-1" SERIES LOW-CAPACITY SMITH PUMPS

This manual contains valuable repair information for the "GC-1" and "MC-1" model types including the following use-specific modifications: "GC-1", "GC-1 L", "GC-1 LZ", "NS", "SA", "NSSA" and "S" versions of the same; "MC-1", "MC-1 L", "MC-1 LZ", "NS", "SA", "NSSA", and "S" versions of the same. Proper procedures are mentioned for changing a mechanical shaft-seal assembly, idler gear shafts, gear set, and bypass valve parts. This manual is an addendum to other repair manuals, parts views, illustrations, and parts lists.

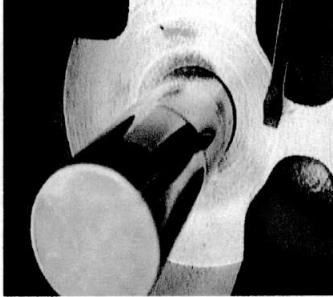
Checking for wear on the pocket ends.

Frequently, a quick visual inspection can save time. For example, if there are visible signs of excessive material removal from the areas shown, the pump cannot be repaired. However, if there is no visible wear, the casings can be used again, and the pump can be repaired.

Since the gear end cover has already been removed from the pump, now is a good time to check the gears, idler gear shafts, casings, and bypass valve parts for wear and proper fit. First, do a simple visual casing check in accordance with the three pictures, above.
